Manhole Inspection Summary

Manhole # S21Y__003MH

Insp Date: **11/21/08 10:24 AM**

Location Address: **2101 WICOMICO ST**

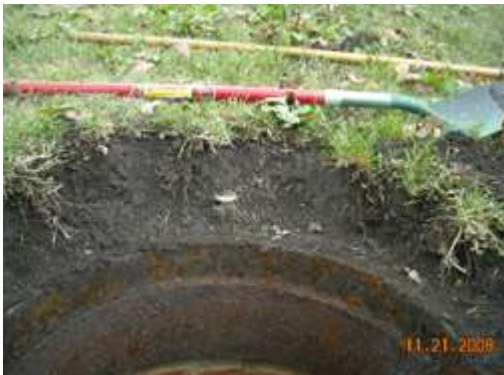
Misc

Comments **FRAME BELOW GRADE 4-8 INCHES; SLOPED GRASS AREA**

Diameter: **24** (in.) Length: **0** (in.) Dist A/B Grade: **-5** (in.)

FRAME BELOW GRADE

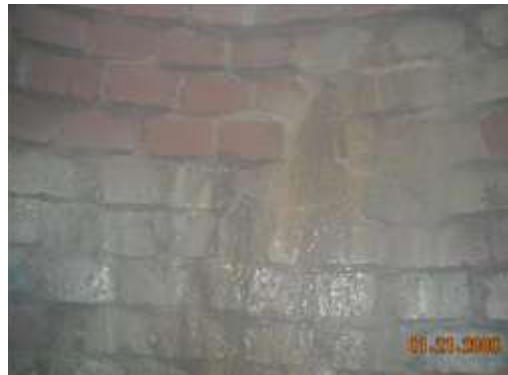
Defect 3

Infiltration: ☐ None ☐ Joint ☐ Cracks ☐ Mortar ☐ Roots ☒ **Wall**

INFILTRATION @ CORBEL WALL

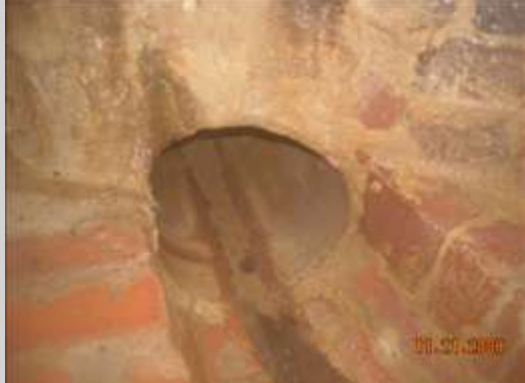
9 O'Clock Inflow

Infiltration: **Evidence** Pipe Seal Cond: **Unknown**
